AN IN-VITRO INVESTIGATION OF THE FIT OF ANTERIOR PORCELAIN  
AND PORCELAIN-METAL FULL-VENEER RESTORATIONS.

Thesis submitted to the University of Sydney  
as partial requirement for admission to the  
degree of Master of Dental Science.

Terry Richard Walton, B.D.S.,

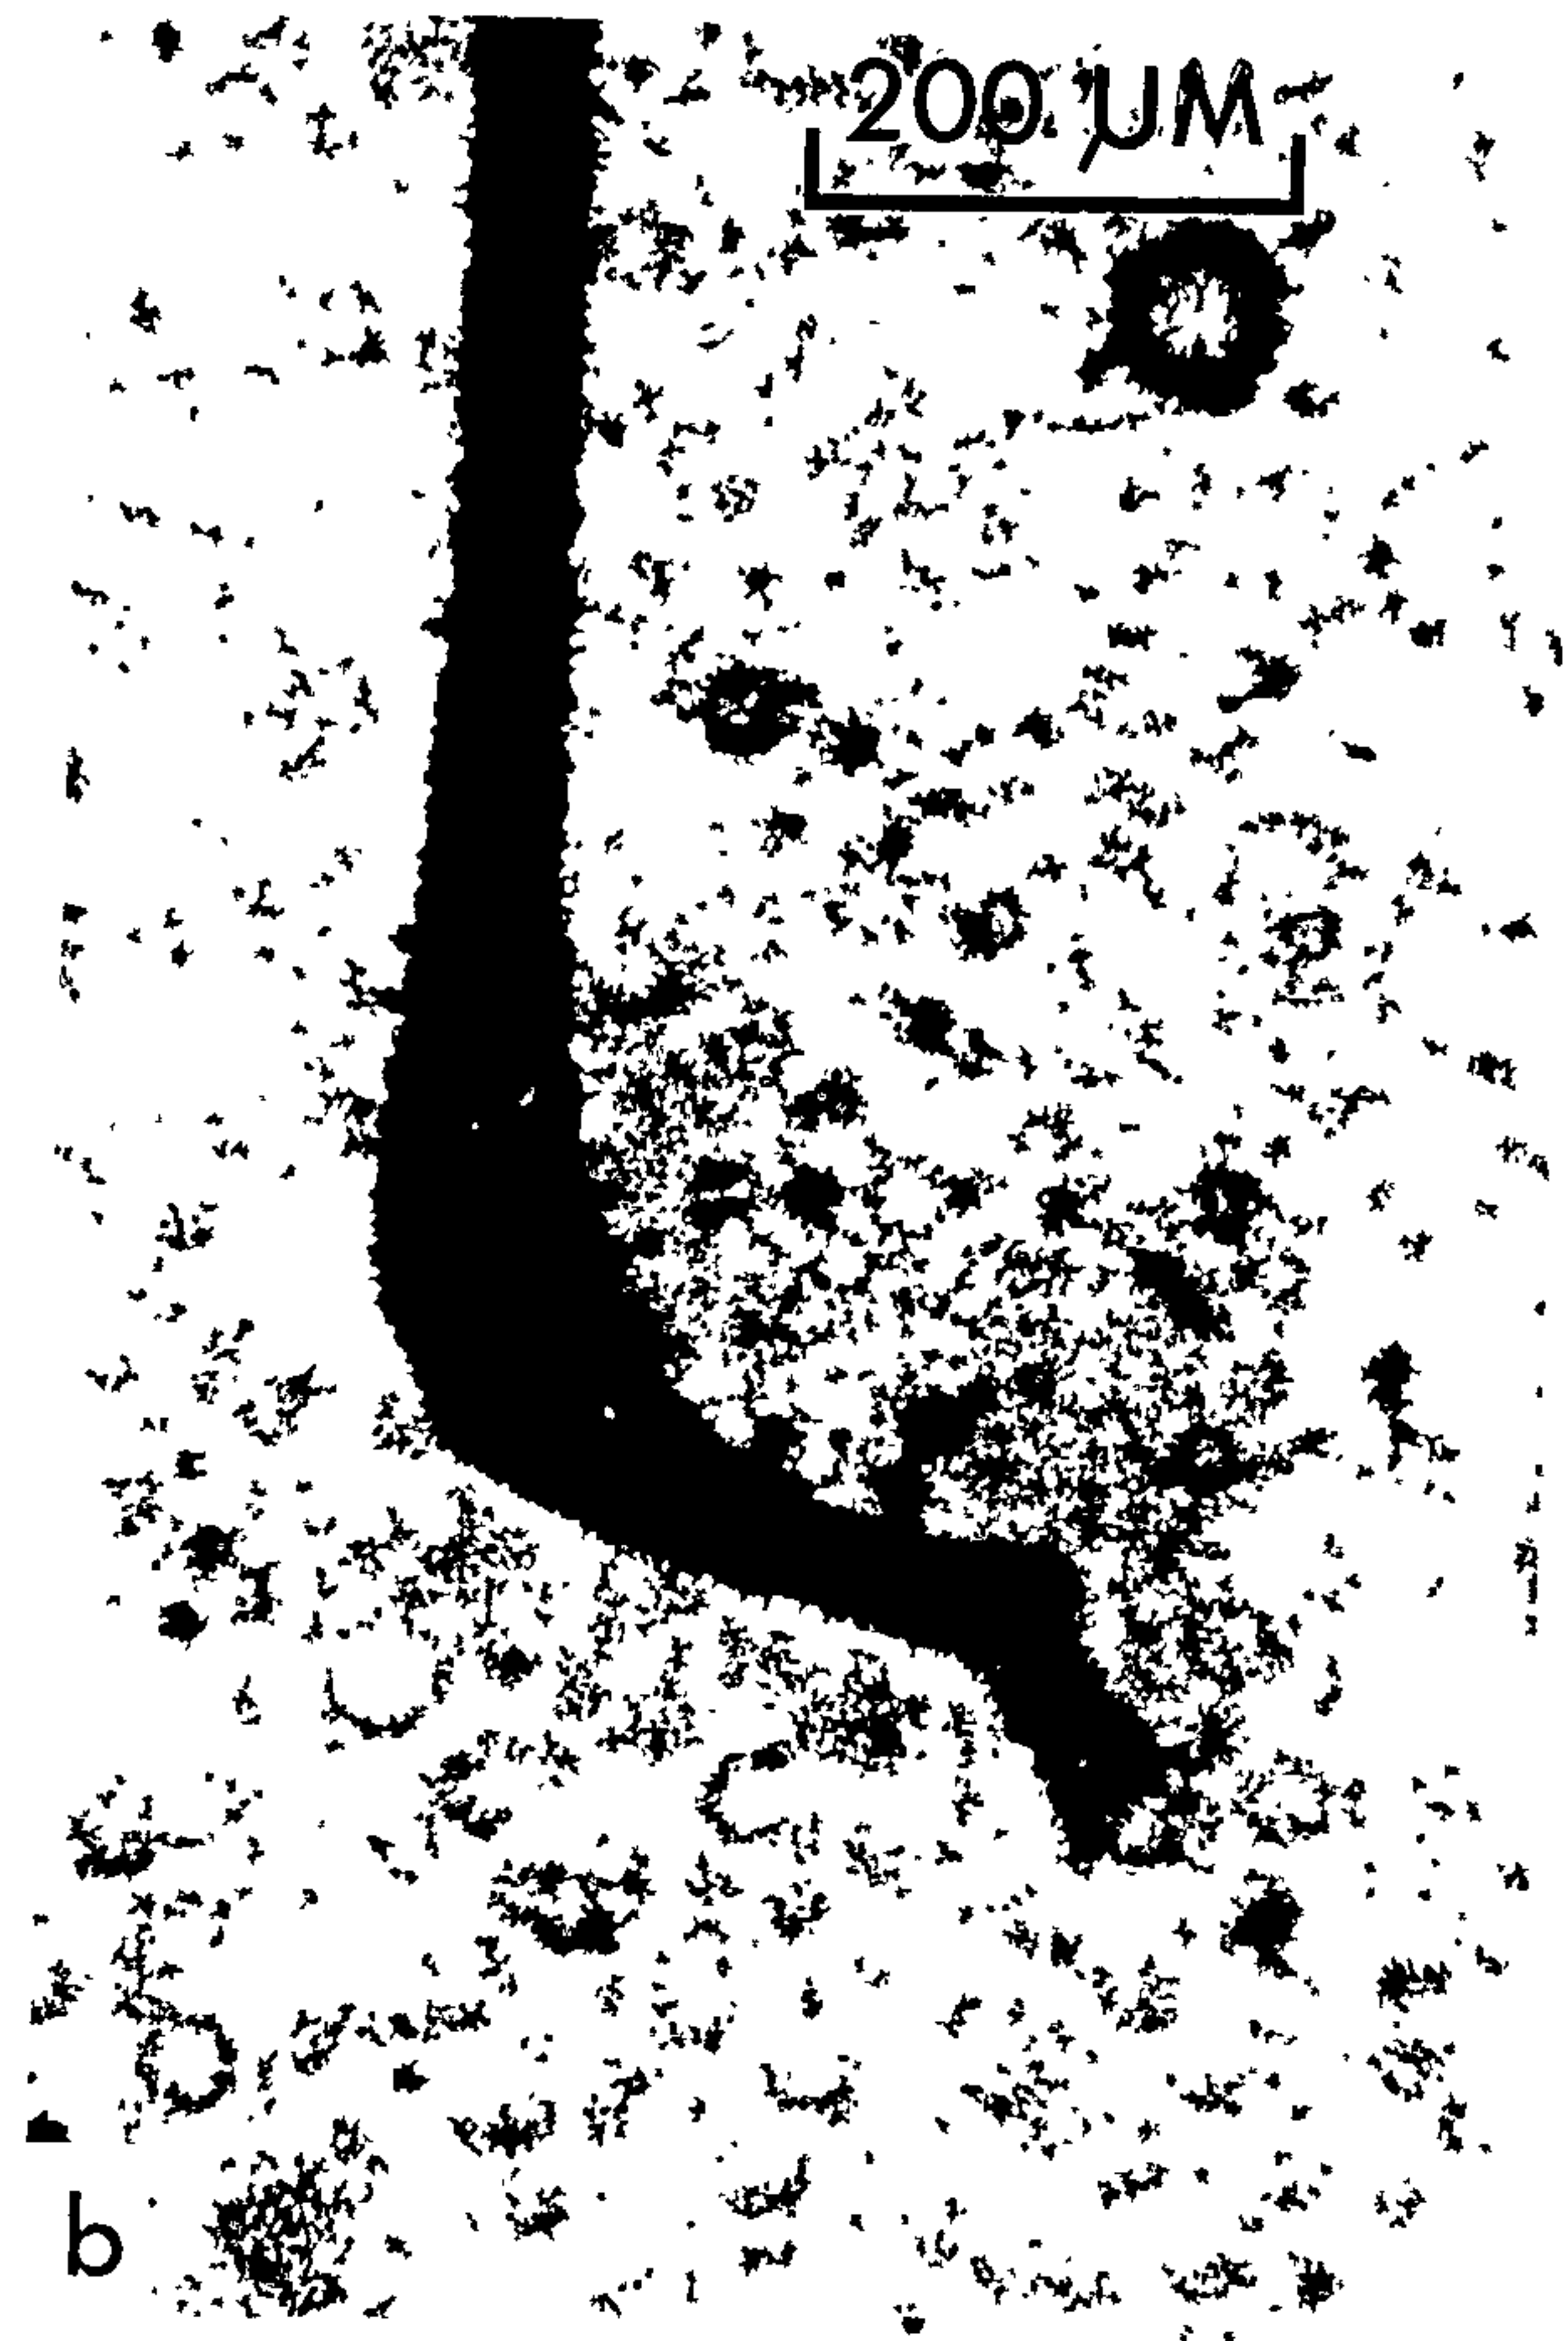
FIGURE 10

Figure 10 - Several photomicrographs of the rubber impressions of the cement space at the shoulder regions of platinum foil porcelain jacket crowns.

Photomicrographs a,b,d show typical rounded internal line angles indicative of the foil being pulled away from this region. The marginal discrepancies however show little distortion and indicate a successful readaptation of the foil to the shoulder of the preparation in that region after the first core firing.

Photomicrograph c shows a region that was not reburnished after the first core firing. The marginal discrepancy is relatively large.

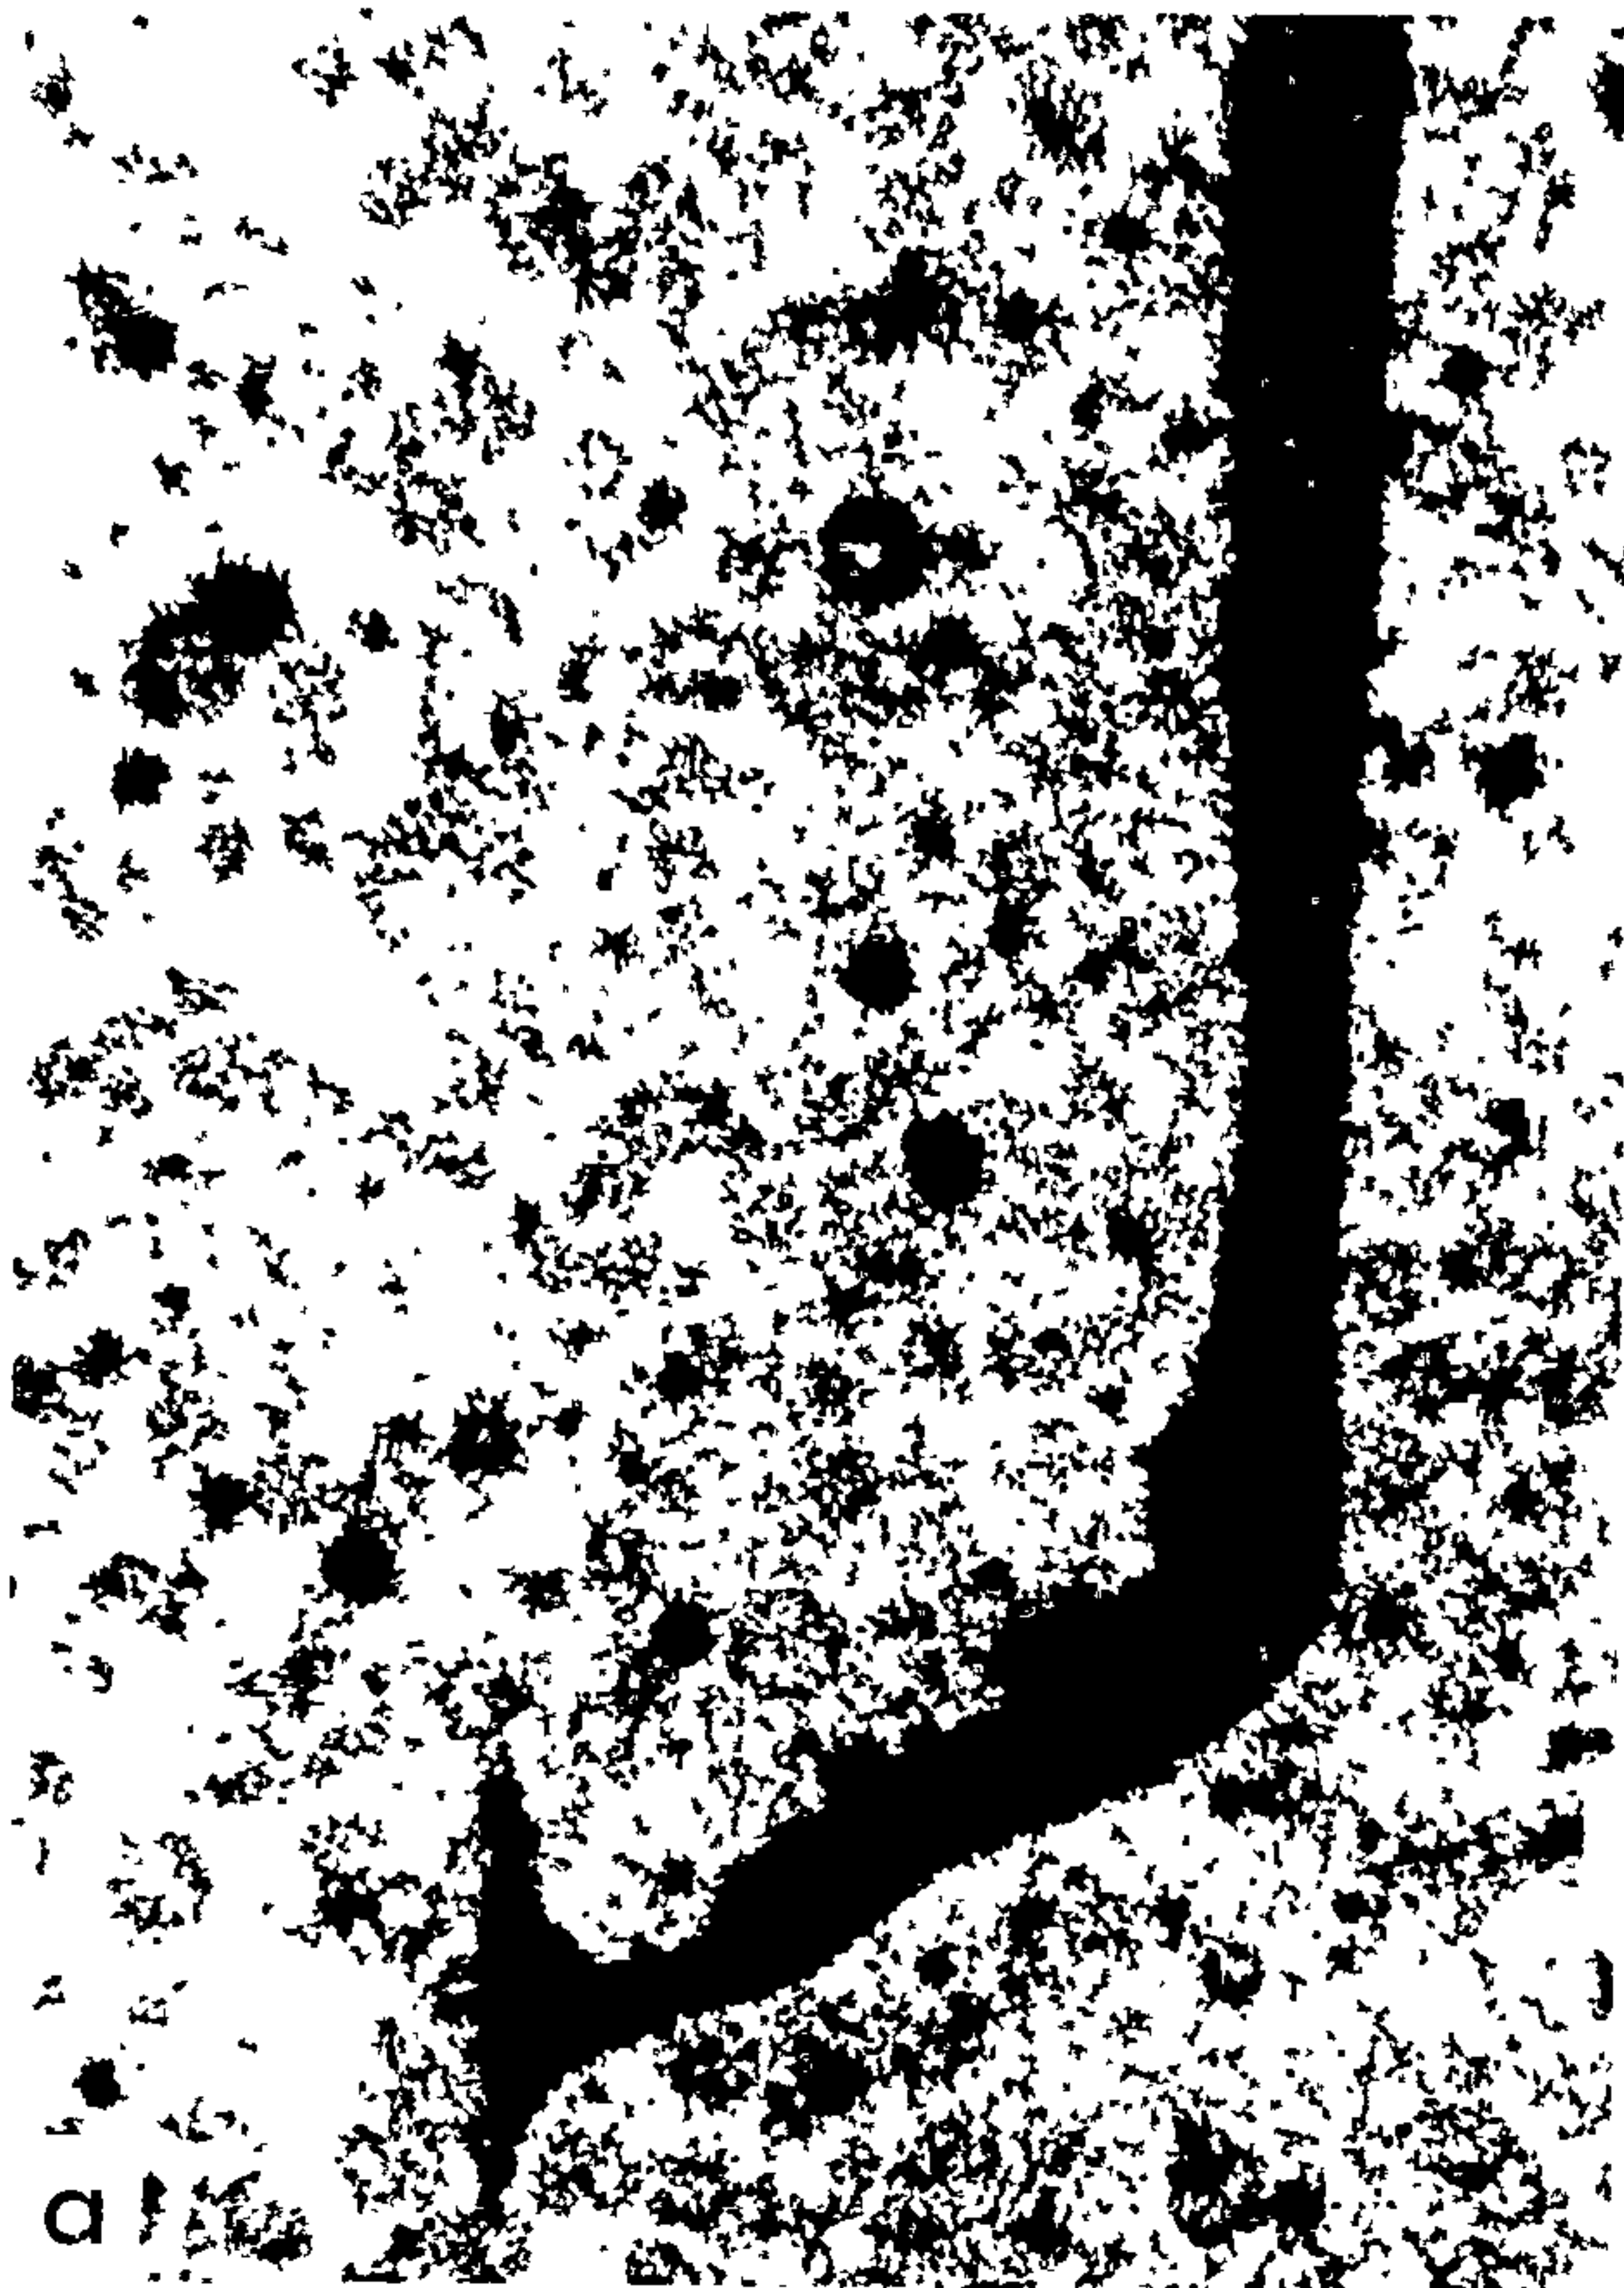
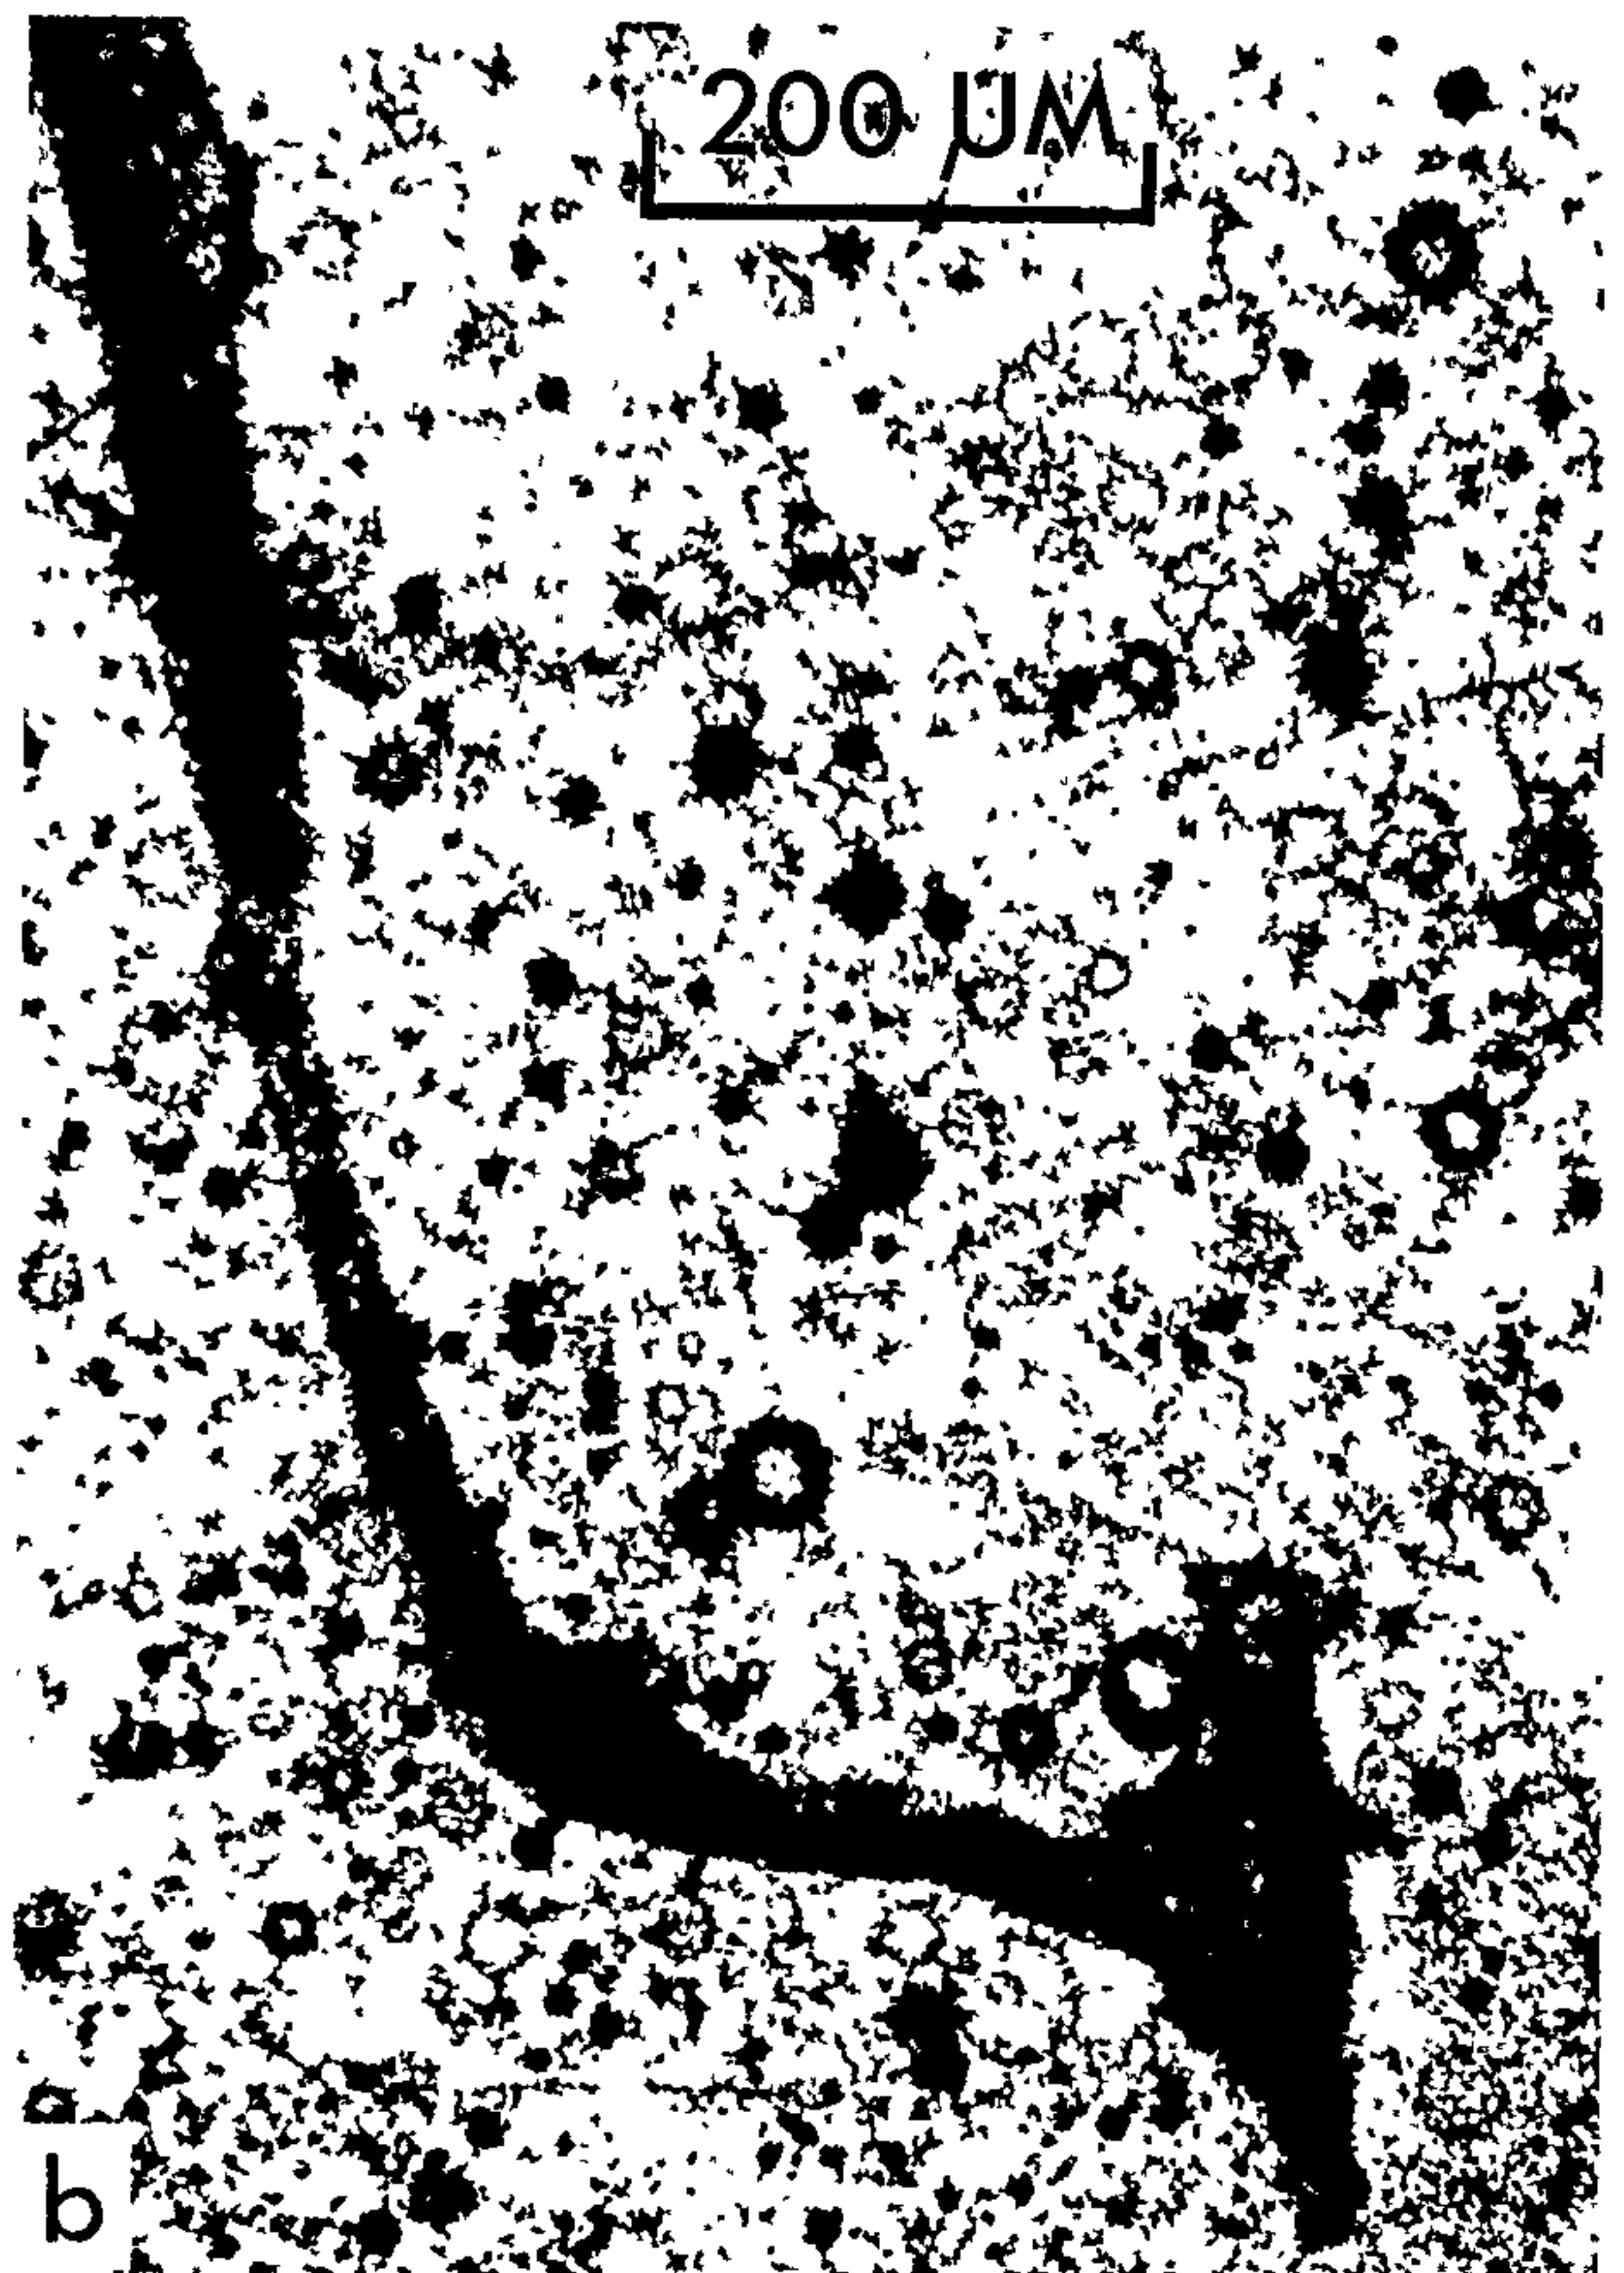
FIGURE 12

Figure 12 - Several photomicrographs of the rubber impressions of the cement space at the shoulder regions of refractory die porcelain jacket crowns.

Note the more uniform width of the cement space compared to the platinum foil sections and the small irregularities corresponding to the rough internal surface of the crowns especially in the shoulder region.

Photomicrographs a and b show small bubbles opening onto the internal surface of the crowns.

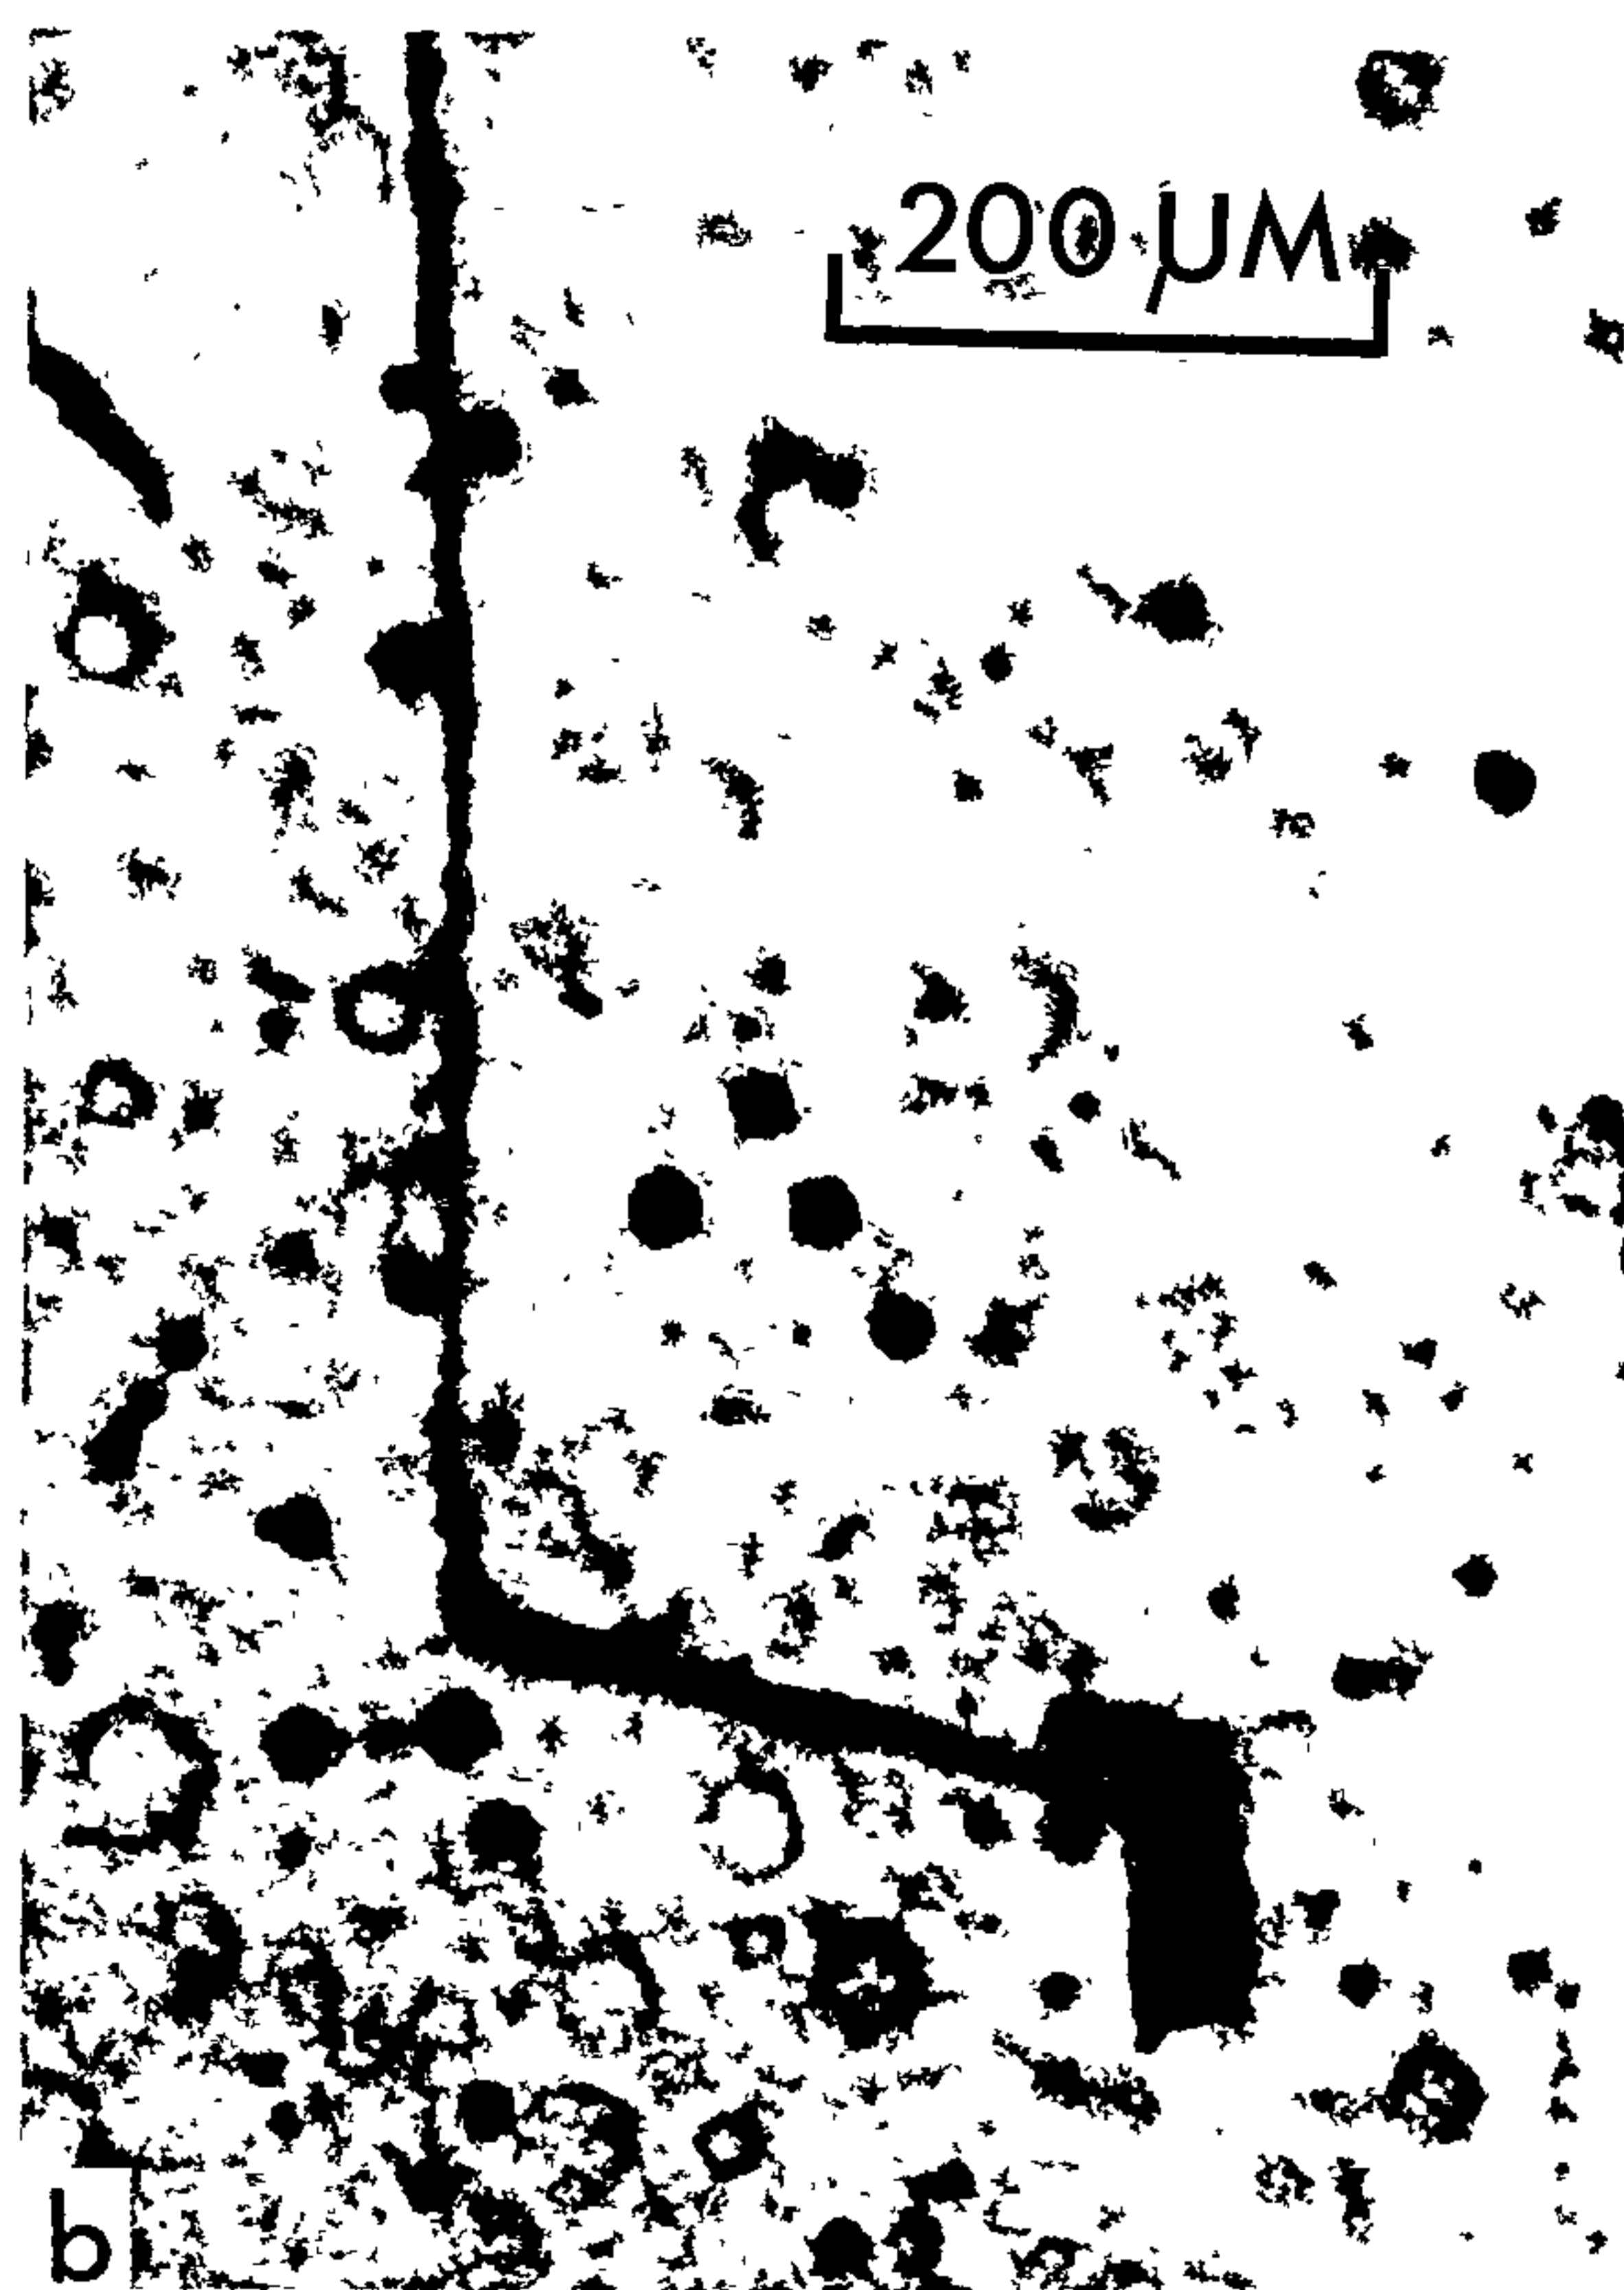
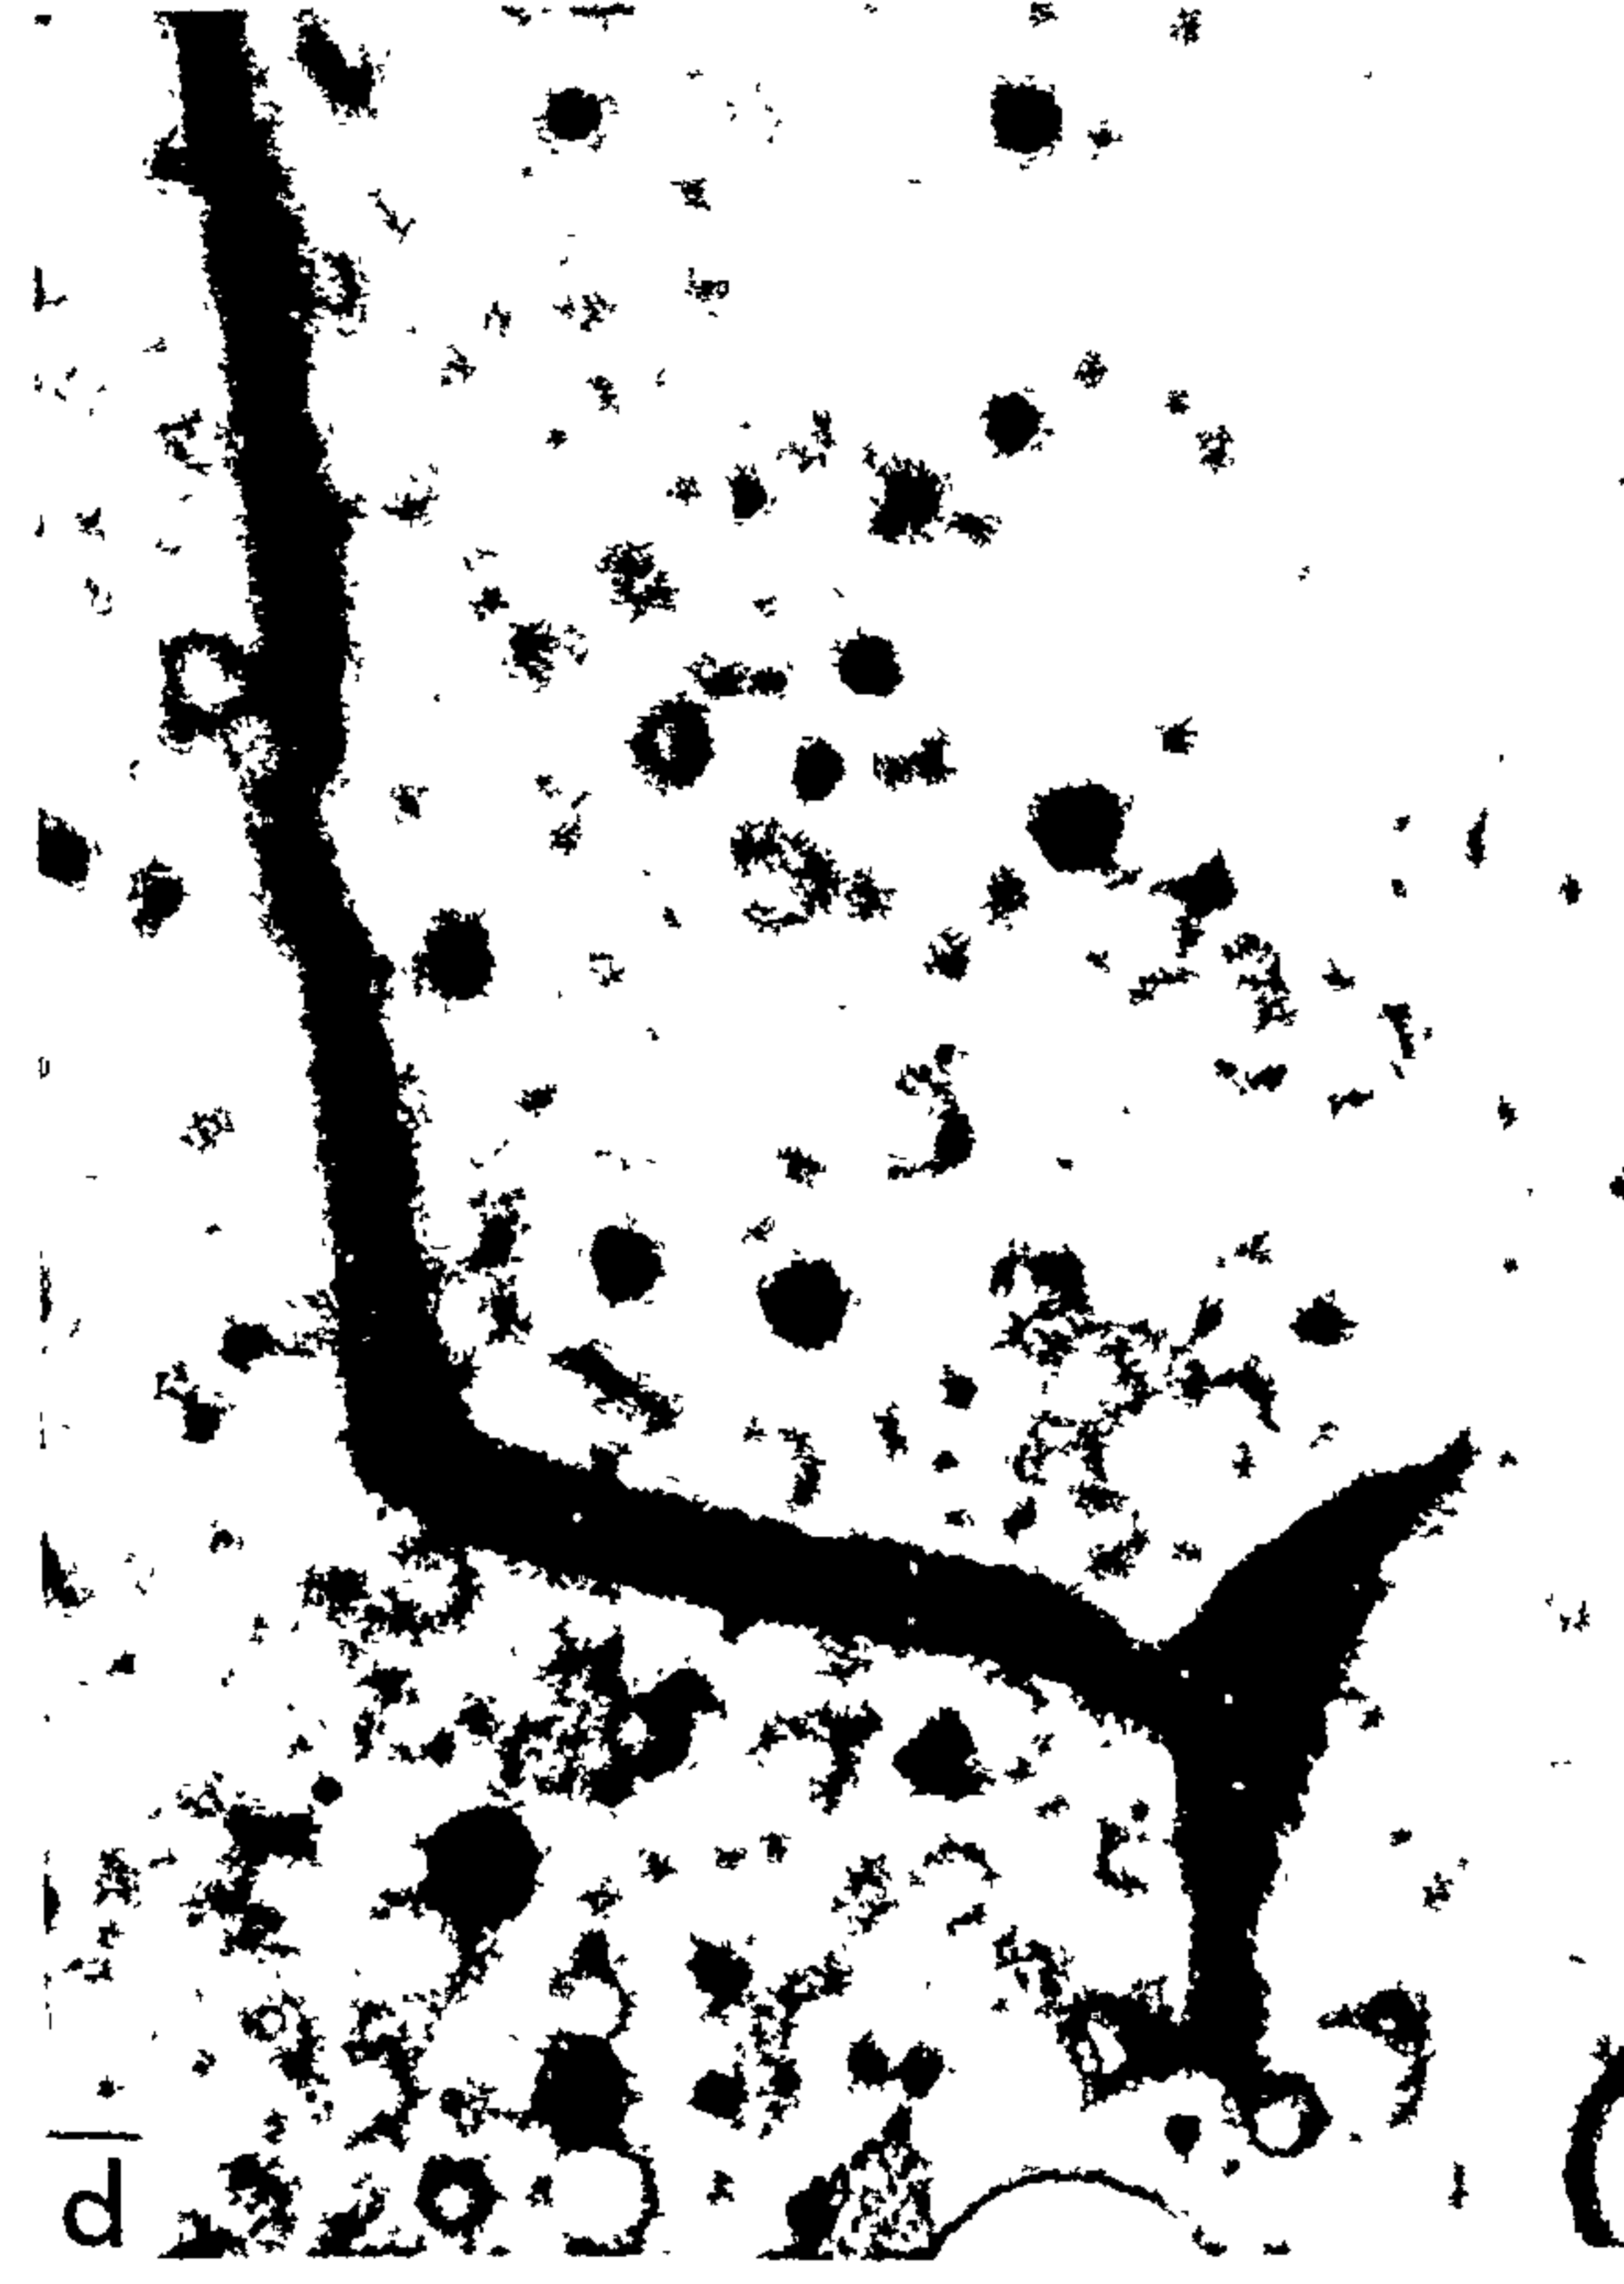
FIGURE 14

Figure 14 - Several photomicrographs of the rubber impressions of the cement space at the shoulder regions of porcelain fused to metal crowns.

Note the smooth surfaces of the Impregum corresponding to the smooth internal surfaces of the metal and the relatively sharp internal line angles of the shoulder regions.

Photographs b and c are of sections of the same crown; b before porcelain application and c after porcelain application.
