The University of Sydney

Centre for Advanced Structural Engineering

**Investigation of Geometric Imperfections
of Support Scaffold Systems**

Research Report No R895

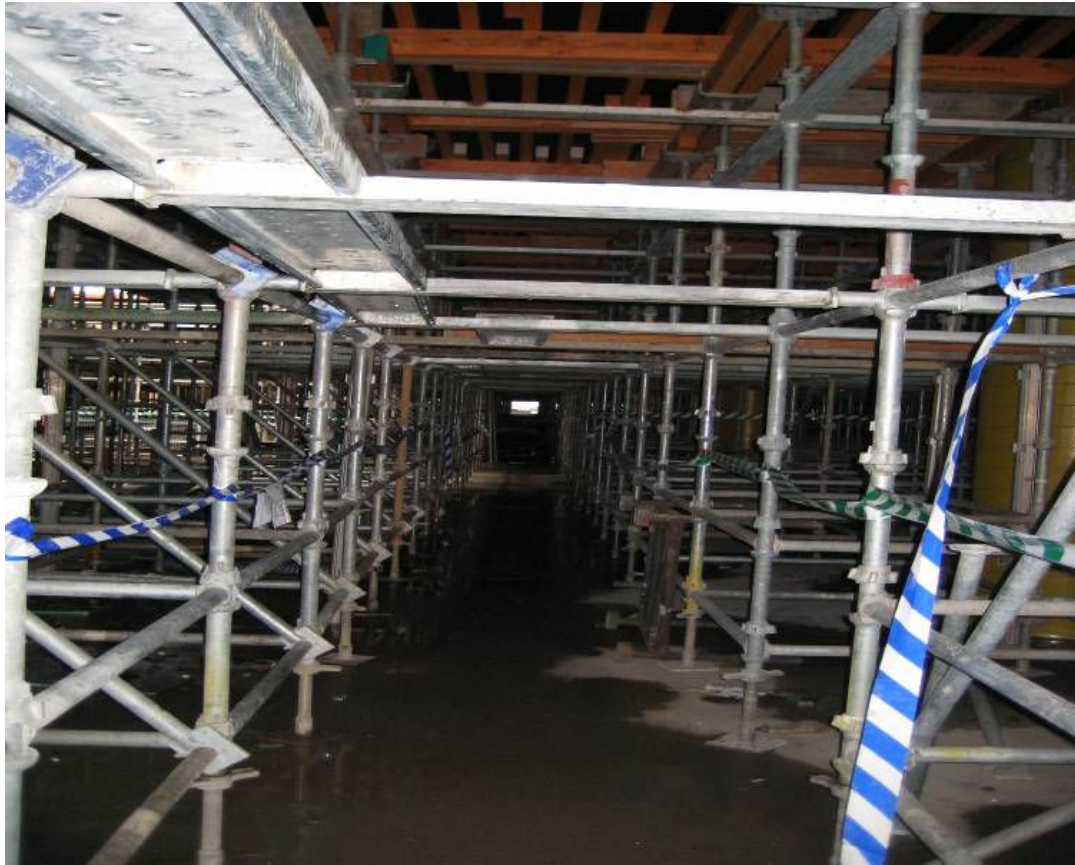
Figure 1: Cuplok scaffold systems

The Cuplok scaffold systems (Figure 1) in this study consists of standards, attached with Cuplok joints, made from cold-formed circular steel tube grade 450 MPa with nominal outside diameter of 48.3 mm and thickness of 4 mm. The grade 350 MPa ledgers made of steel tube with nominal outside diameter of 48.3 mm and thickness of 3.2 mm attached with end blades are connected to the standards via Cuplok joints. The telescopic braces with hook ends were made of 48.3 mm x 4.0 mm outer tube and 38.2 mm x 3.2 mm inner tube with nominal yield stress of 400 MPa. The adjustable jacks with 600 mm maximum extension capability were made of 36 mm diameter threaded steel rod in grade 430 MPa and the base plates were 180 mm x 180 mm x 10 mm in dimensions with nominal yield stress of 250 MPa. The U-heads attached to the jacks have clear width of 210 mm.

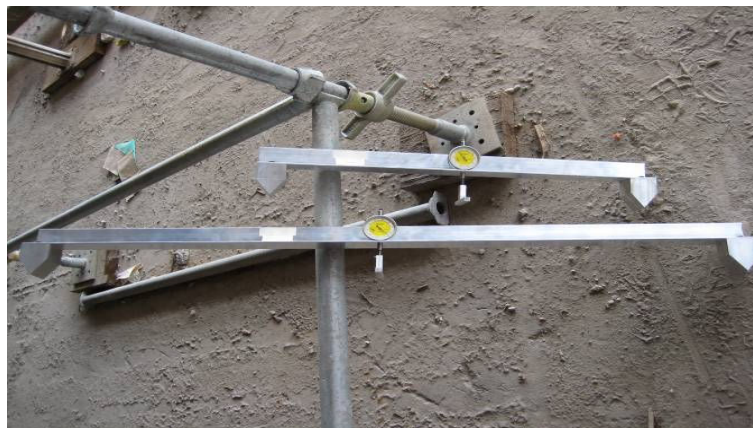
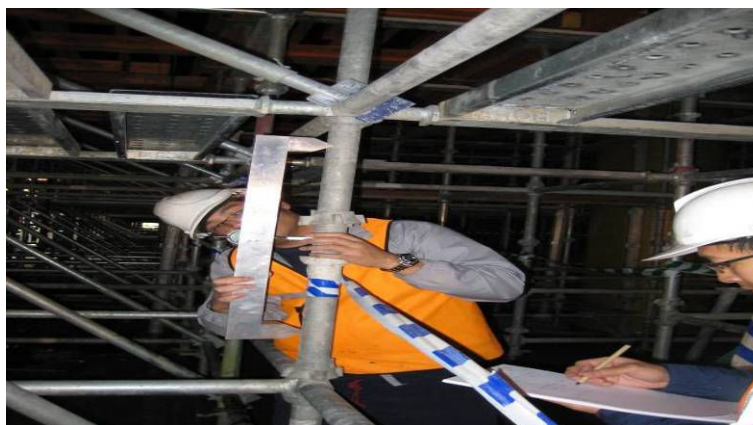
Figure 3: (a) Device used to measure out-of-straightness (b) Actual measurement

A special-made device instrumented with a dial gauge was used to measure the out-of-straightness (crookedness) of the standards (uprights) at the mid-height of each lift in two perpendicular directions aligned with the ledgers and referred to as the N-S and E-W directions. Figure 2 shows schematics of the device in two different lengths that fit into 1 m and 1.5 m lift heights of the scaffold systems for out-of-straightness measurement. The dial gauge attached to the device was calibrated with a perfectly flat surface so that it read directly the imperfection value once aligned with the standard. Figure 3(a) shows the actual devices used to measure the out-of-straightness at mid-height of the standard in the lift and Figure 3(b) exemplifies the measurement of the out-of-straightness of a 1 m lift standard on one of the sites.

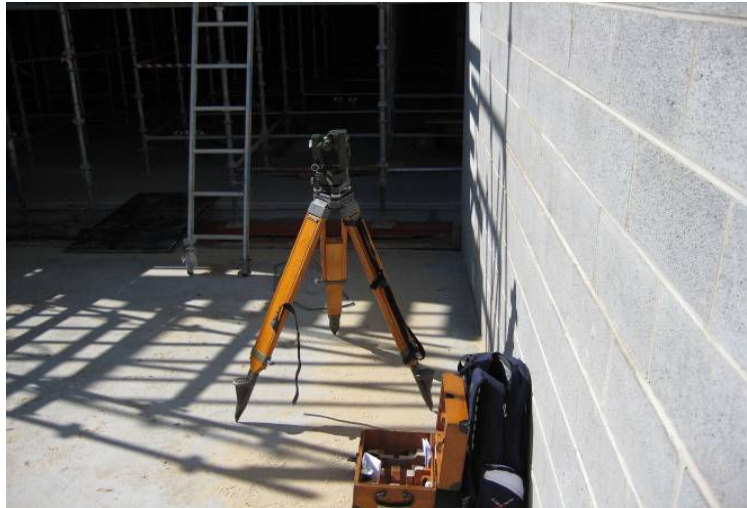
Figure 4: Theodolite employed for storey out-of-plumb measurement

A theodolite was set up to measure the angle difference between top and bottom of the frame in order to compute storey out-of-plumb (Figure 4). The horizontal distance between the standard (upright) and the theodolite was also measured together with the angle difference so that a simple trigonometric calculation could be carried out to calculate the storey out-of-plumb. Measurements were made for both the N-S and E-W axes of the construction plans.

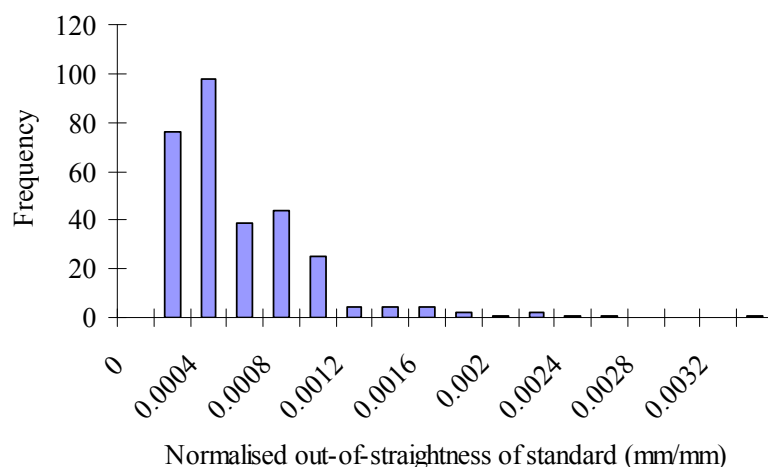
Figure 5: Histogram of normalised out-of-straightness of the standards (δ/L_h)

A total of 302 on-site measurements of out-of-straightness of the standard were taken and 80 measurements of storey out-of-plumb were acquired. In addition, 74 measurements of loading eccentricity were obtained from various construction sites. From data observation, it was found that there was no correlation between the out-of-straightness of the standards and the storey out-of-plumb; moreover, the directions (axes) of these geometric imperfections were random. The directions of the loading eccentricity were shown to be random and occurred on either side perpendicular to the bearer. The results of out-of-straightness of the standards were normalised with the lift height and the results of storey out-of-plumb were normalised with the storey height of the scaffold systems measuring from base plate up to the U-head. Figures 5-7 show the histograms of normalised out-of-straightness of the standards (δ/L_h where δ is the deflection at mid-height of the lift and L_h is the lift height), normalised storey out-of-plumb (Δ/H where Δ is the sway and H is the height of the scaffold systems) and loading eccentricity, respectively. A complete data can be found in Appendix A.

The mean normalised out-of-straightness of the standards including standards with and without spigot joints is 0.00048 ($L_h/2080$) with standard deviation of 0.00042; however, it is computed that the mean normalised out-of-straightness of the standards with spigot joints is 0.0013 ($L_h/770$) with standard deviation of 0.0008 and the mean normalised out-of-straightness of the standards without spigot joints is 0.0004 ($L_h/2500$) with standard deviation of 0.0003. The mean normalised storey out-of-plumb is 0.0016 ($H/625$) with standard deviation of 0.0005 whereas the mean loading eccentricity is 18.09 mm with standard deviation of 10.67 mm.

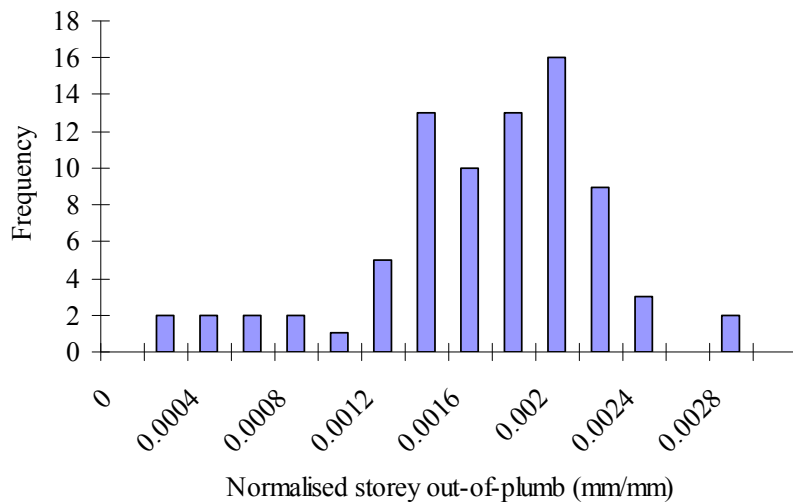
Figure 6: Histogram of normalised storey out-of-plumb (Δ/H)

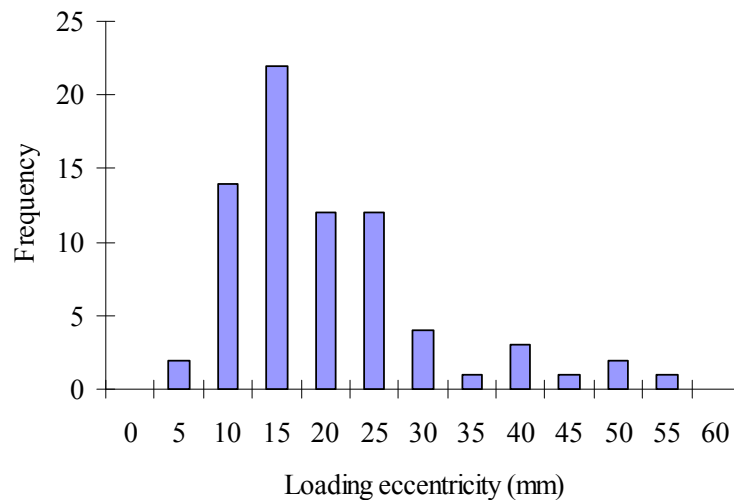
Figure 7: Histogram of loading eccentricity

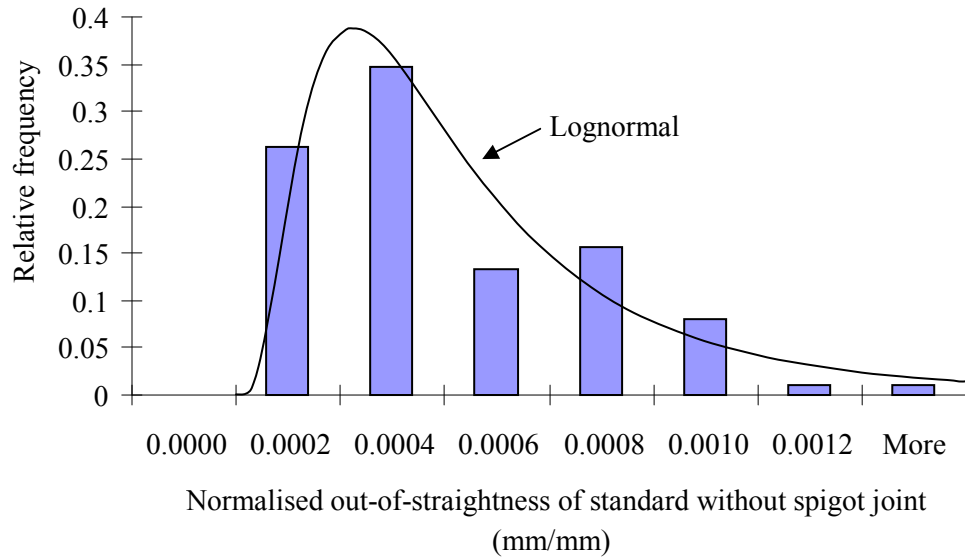
Figure 8: Fitted lognormal distribution of normalised out-of-straightness of standards without spigot joints

Ultimately, these uncertainties must be studied by statistical methods to find appropriate distributions so that probabilistic assessment of the strength of the support scaffold systems can be carried out. Table 1 shows fitted statistical functions for the normalised out-of-straightness of the standards (δ/L_h), the normalised storey out-of-plumb (Δ/H) and the loading eccentricity of the support scaffold systems. The fitted probability distributions are shown graphically in Figure 8-11.

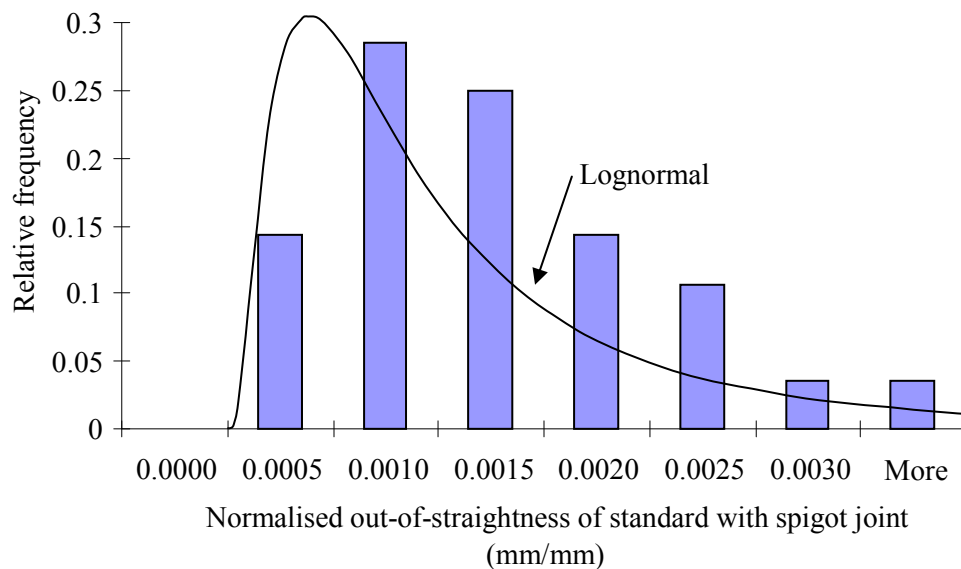
Figure 9: Fitted lognormal distribution of normalised out-of-straightness of standards with spigot joints

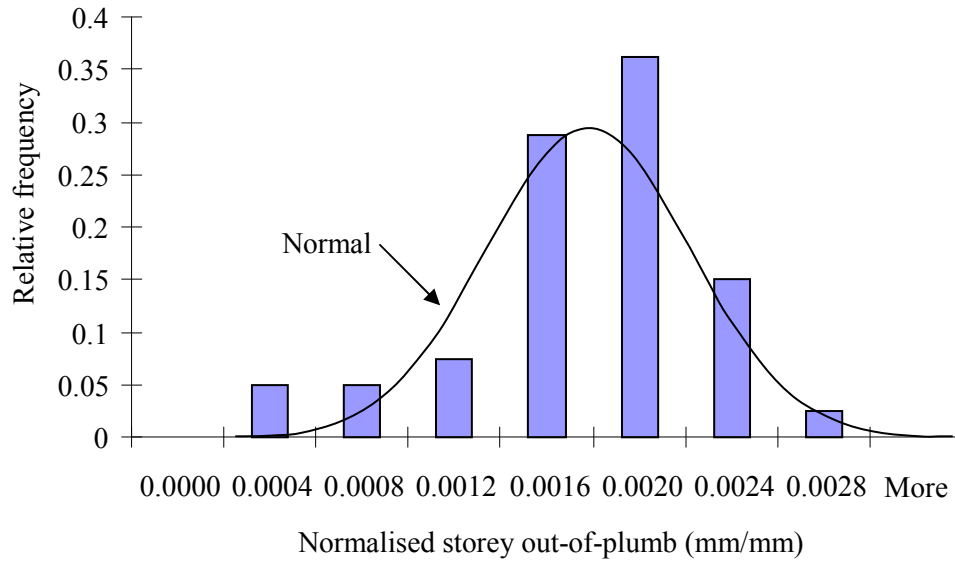
Figure 10: Fitted normal distribution of normalised storey out-of-plumb

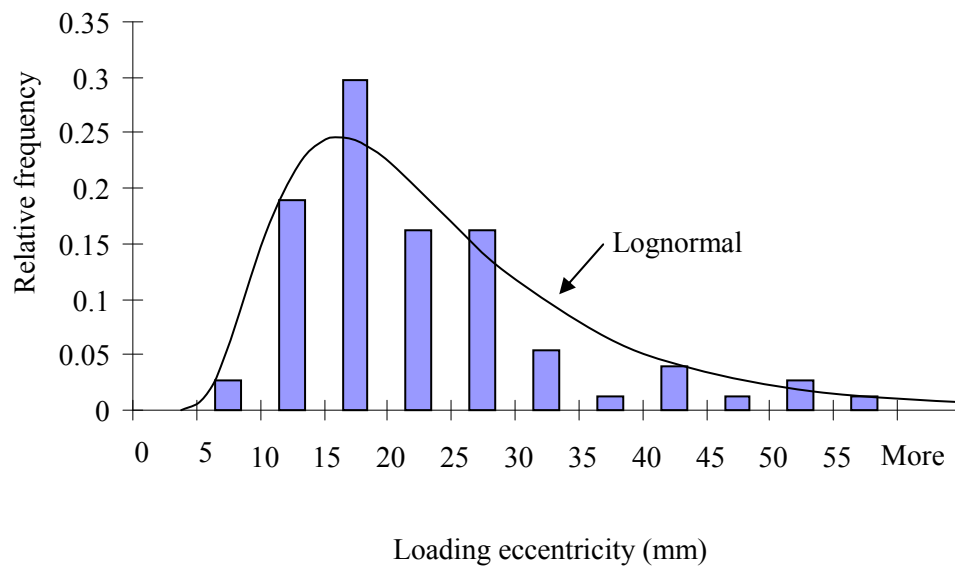
Figure 11: Fitted lognormal distribution of loading eccentricity
