## traces of the body and building

THIS THEATRE OF ANTHONY WILL EXPLORE THE IDEA OF THE TRACES LEFT BEHIND BY HUMANS AND BUILDINGS. IT WILL REFLECT TRACES OF THE PHYSICAL HUMAN BODY AND TRACES OF THE HISTORY AND PHYSICAL BUILDING OF ST ANNA'S, WHILE ALSO ALLOWING THEATRE GOERS TO LEAVE THEIR OWN TRACES, IMPRINTS AND RESIDUE ON THE THEATRE SPACES.

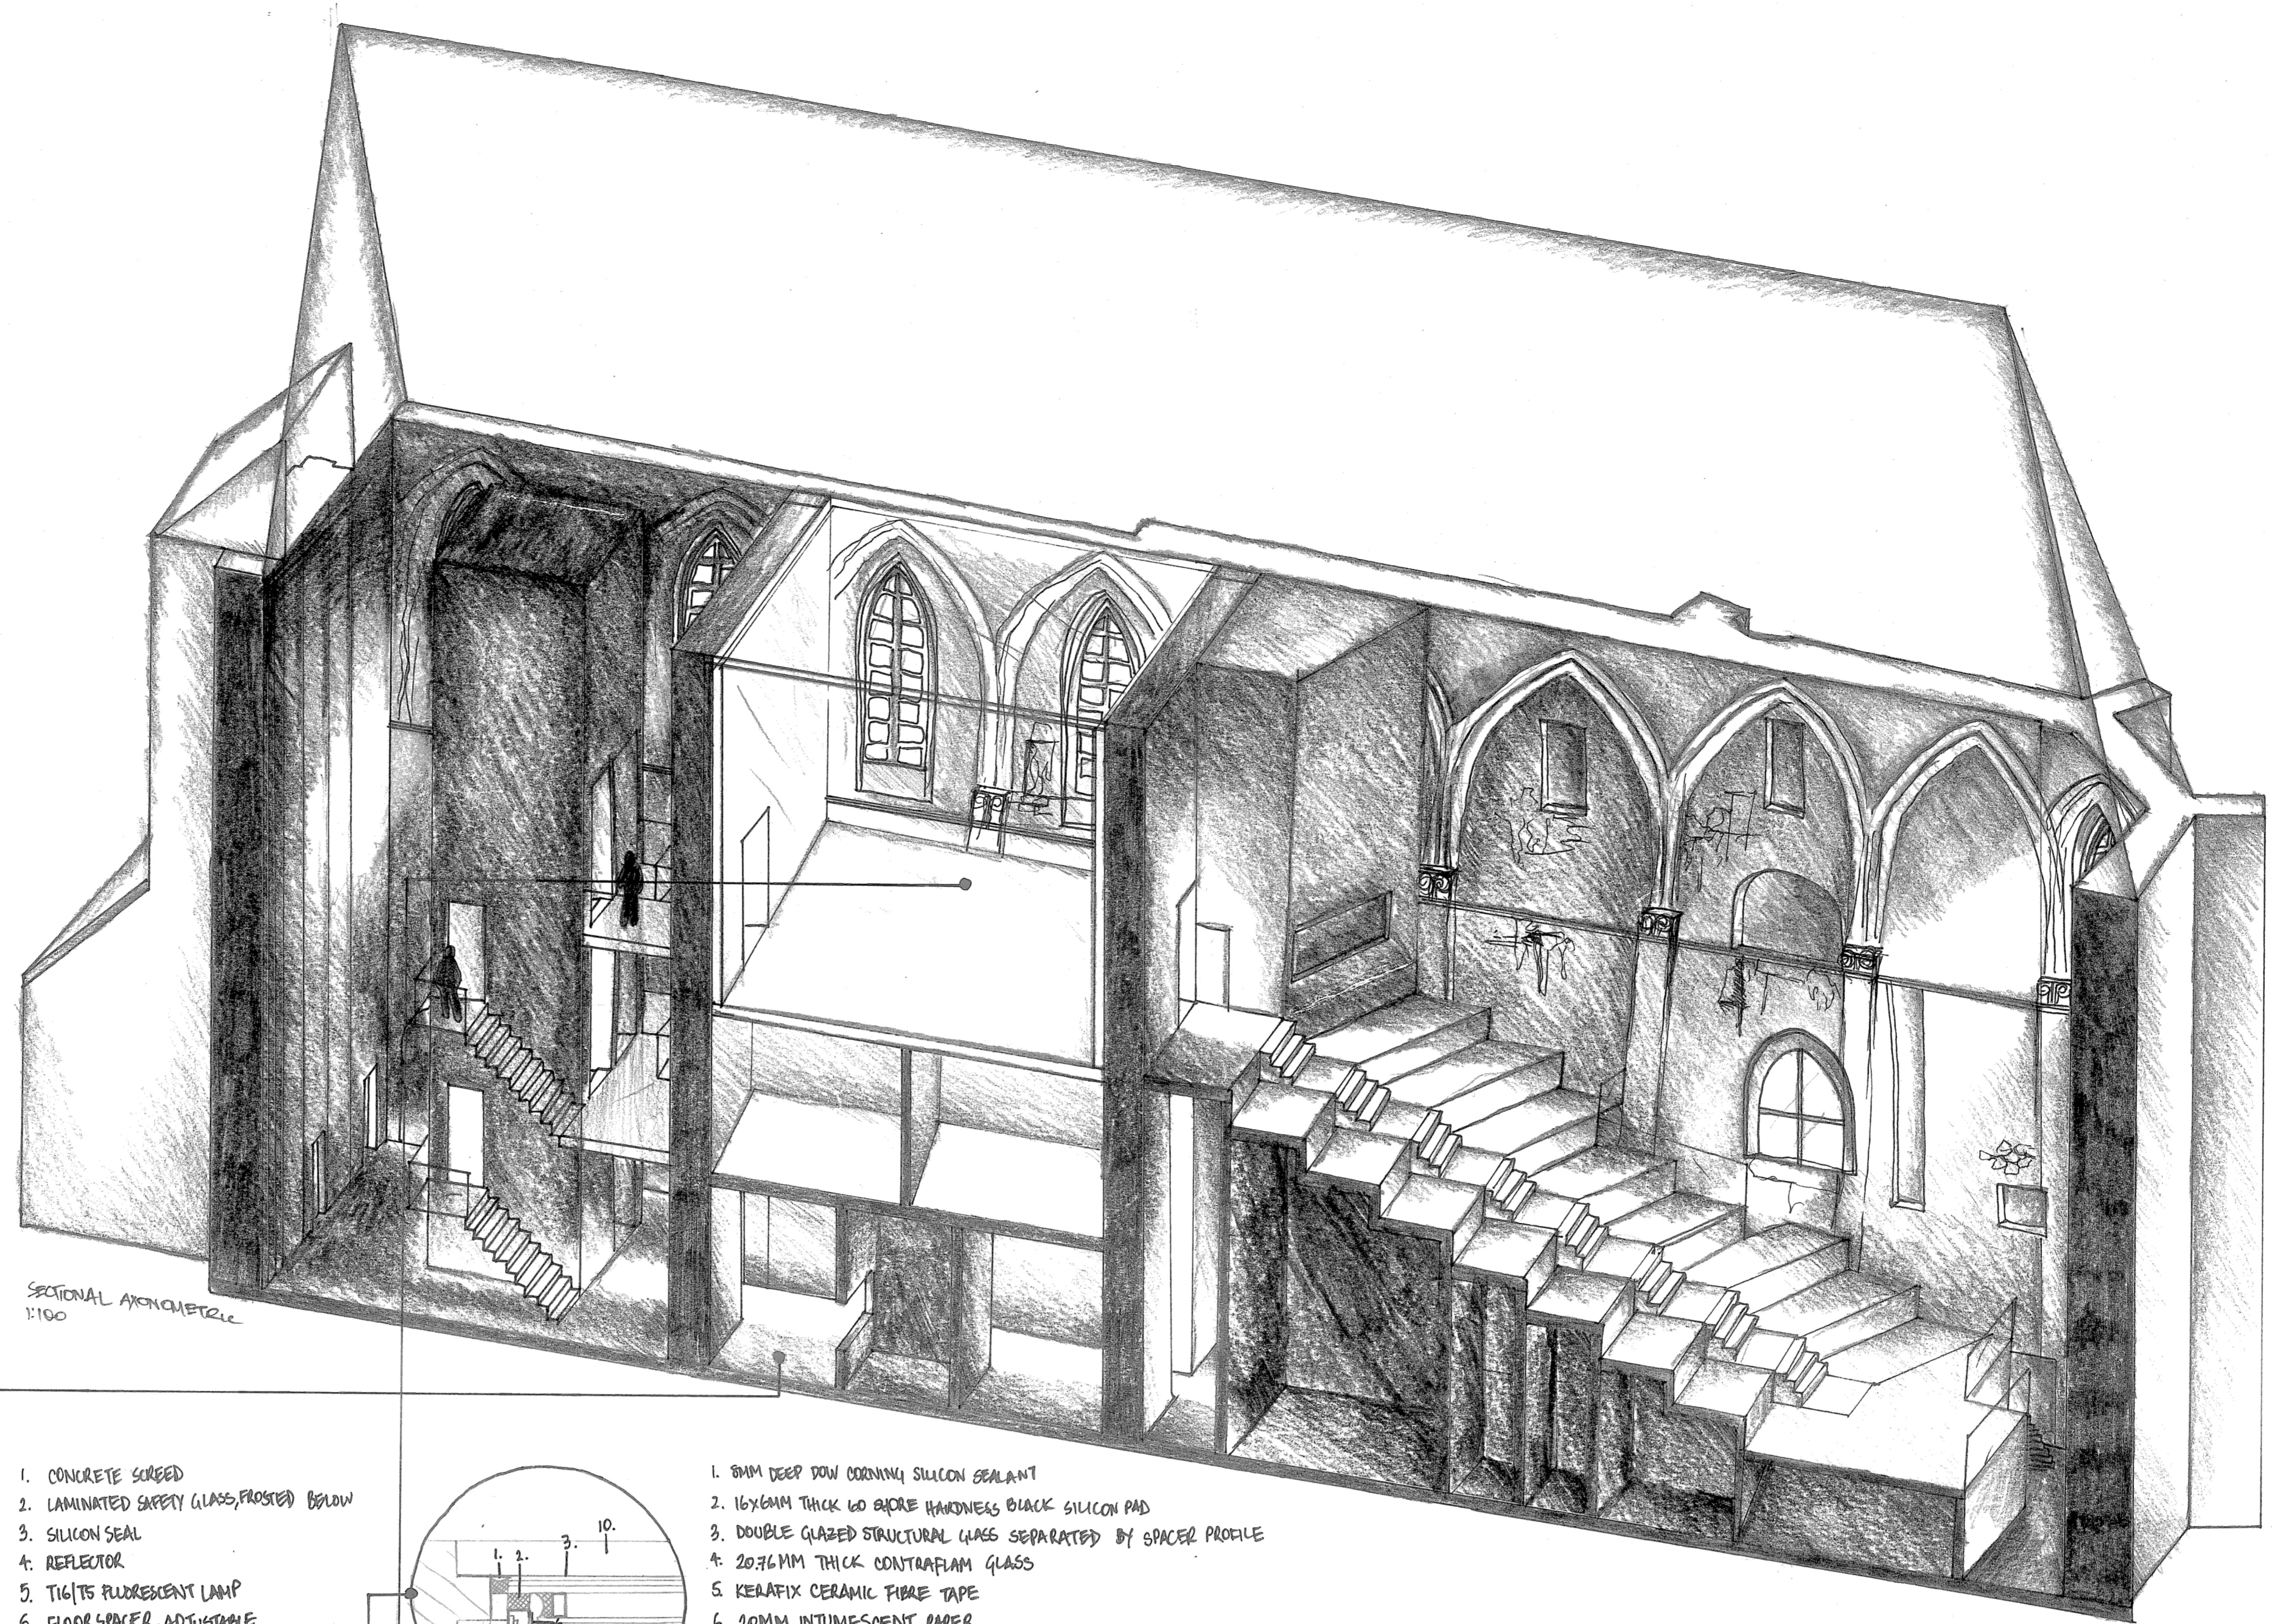
1. CONCRETE SLAB
2. LAMINATED SAFETY GLASS/FROSTED BELOW
3. SILICON SEAL
4. REFLECTOR
5. TIGHTS FLUORESCENT LAMP
6. FLOOR STRUCKER, ADJUSTABLE
7. JUNCTION ANGLE BAR
8. ORIGINAL CHURCH MASONRY WALL
9. REINFORCED CONCRETE FLOOR SLAB

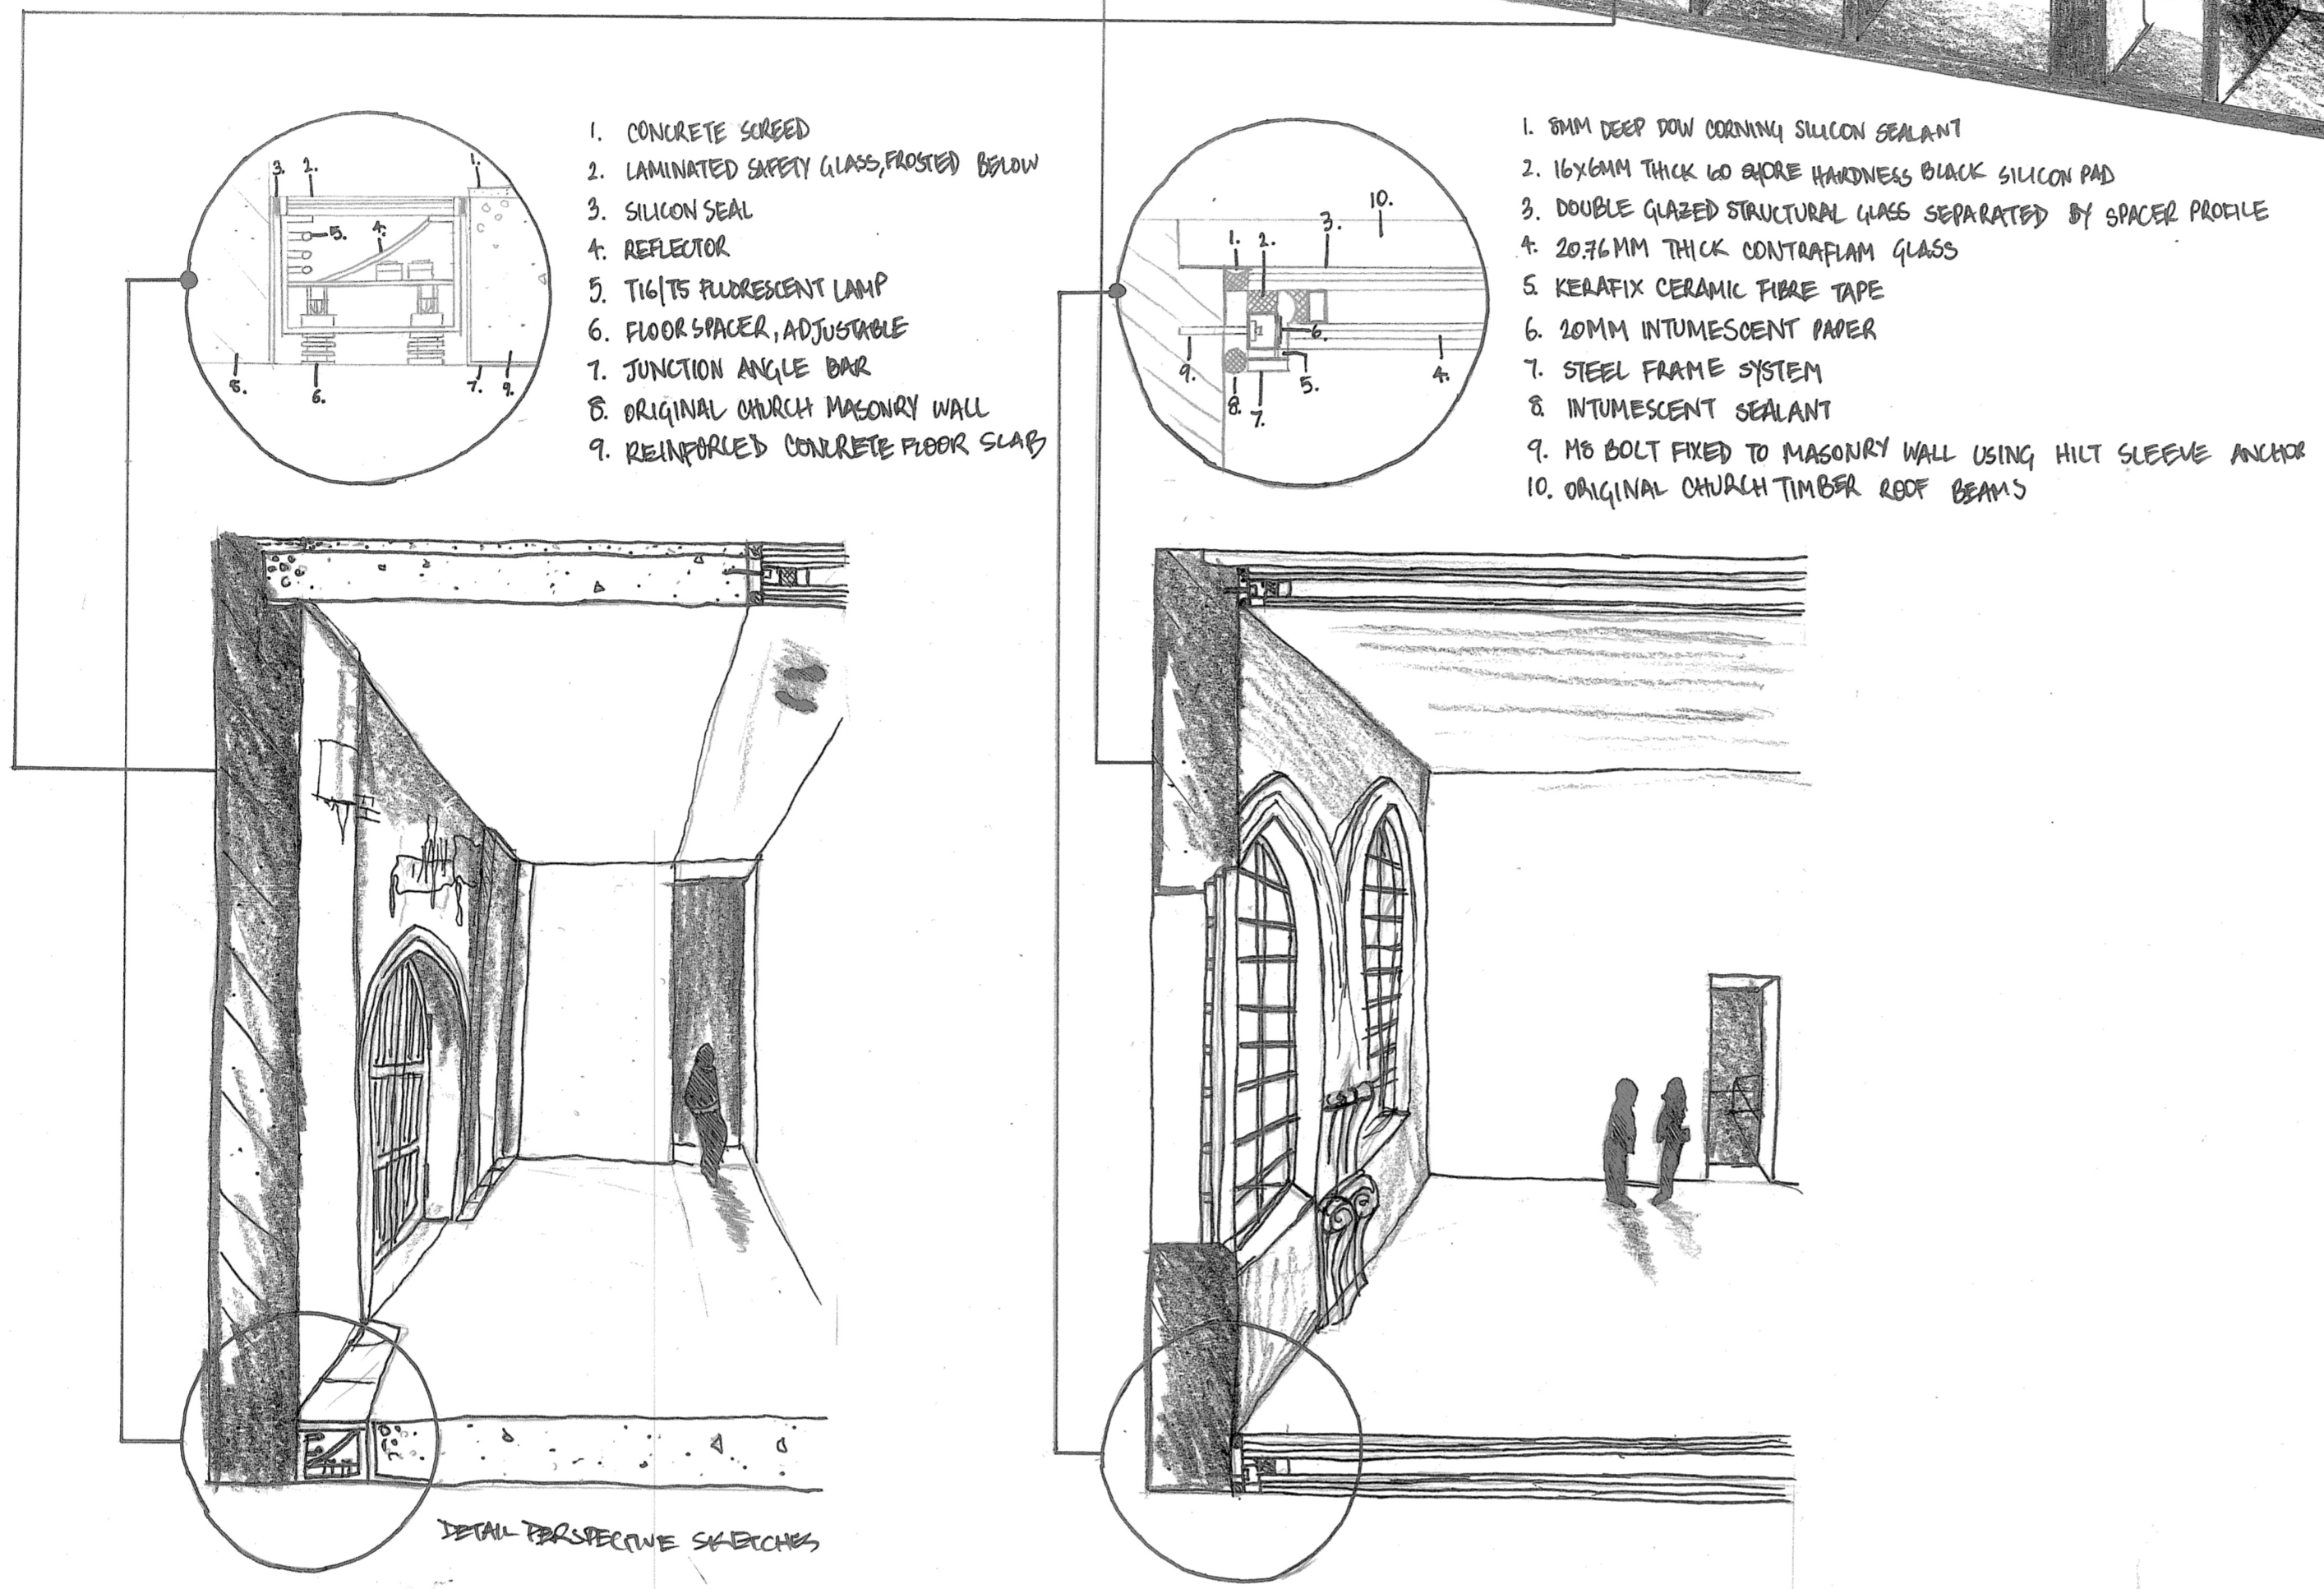
1. 20MM DEEP DOW CORNING SILICON SEALANT
2. 165MM THICK 60 MICRO HARDNESS BLACK SILICON PAD
3. DOUBLE GLAZED STRUCTURAL GLASS SEPARATED BY SPACER PROFILE
4. 203.2MM THICK CONTAMELAM GLASS
5. REPAIR CERAMIC FIBRE TAPE
6. 30MM INTUMESCENT PAPER
7. STEEL FRAME SYSTEM
8. INTUMESCENT SEALANT
9. M6 BOLT FIXED TO MASONRY WALL USING HILT SLEEVE ANCHOR
10. ORIGINAL CHURCH TIMBER ROOF BEAMS
